**Hazardous Building Materials Survey  
5260 Western Avenue  
Chevy Chase, MD 20815  
HCEA Project No. 24646B**

RE: Hazardous Building Materials Survey  
**5260 Western Avenue**  
**Chevy Chase, MD 20815**  
HCEA Project No. 24646B

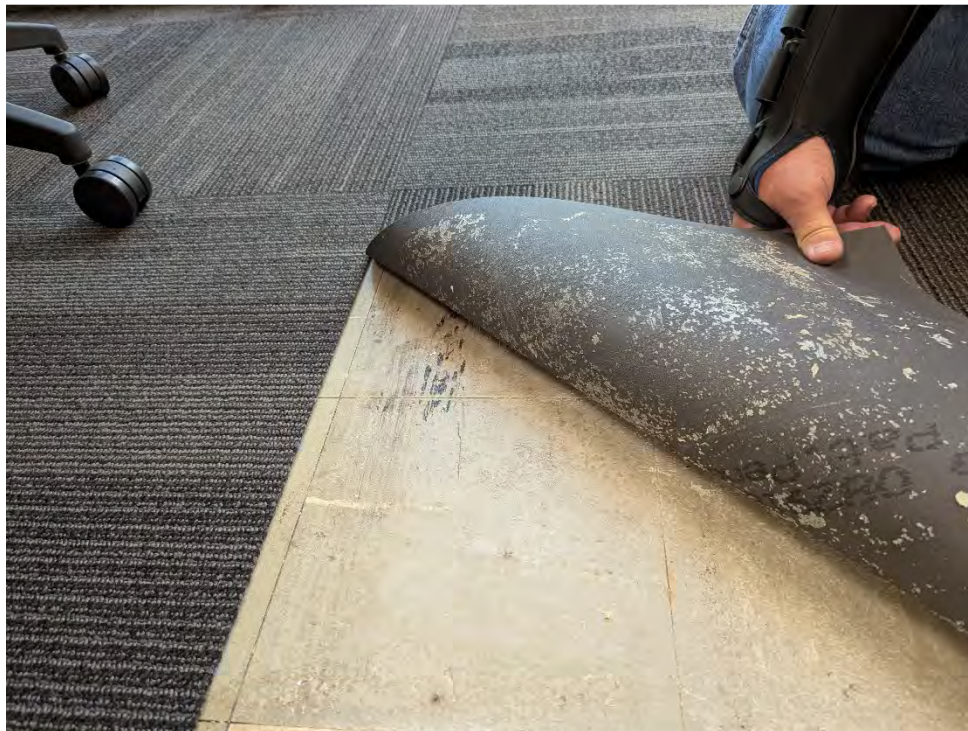
Photograph 1: Gray 9x9" floor tile, observed in each building. Sample numbers 62-B and C, 11-B and C, and 41-B and C.

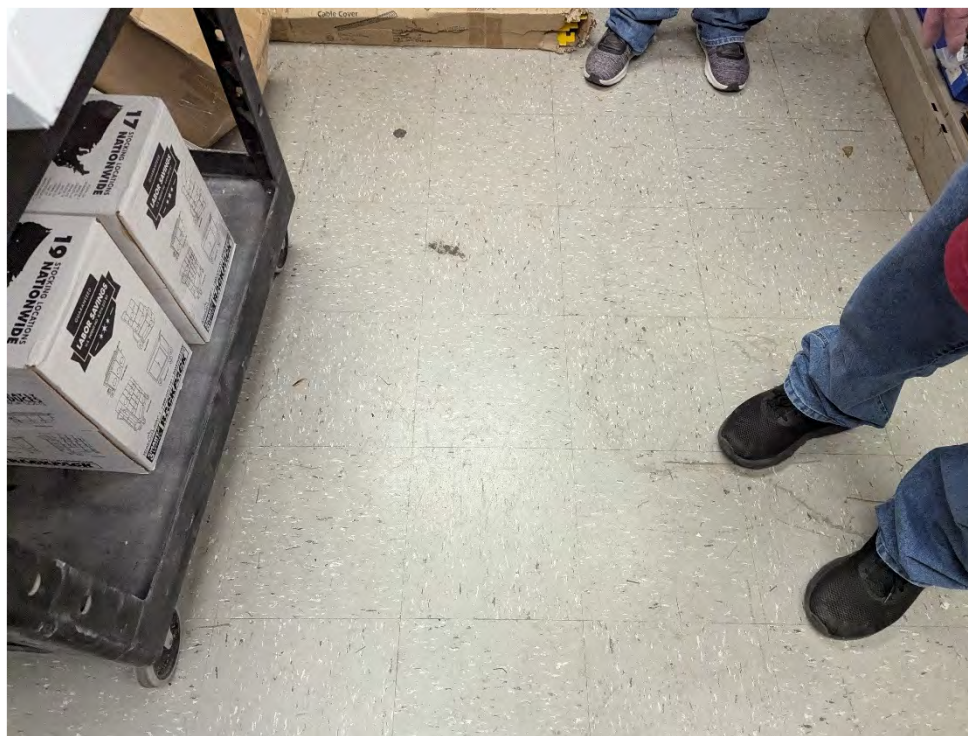
Photograph 2: Gray 12x12" floor tile, observed in the Original building. Sample number 68-A.

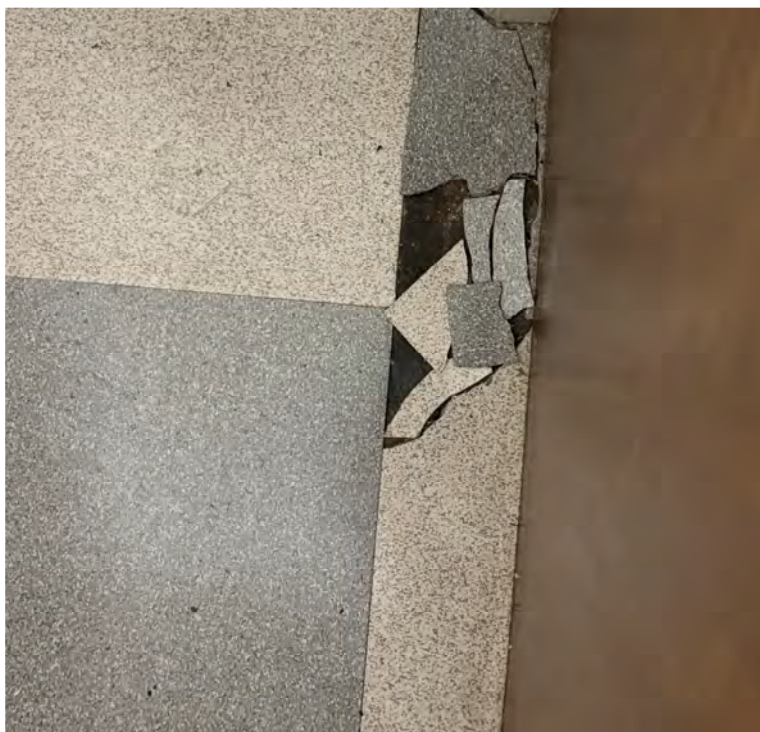
Photograph 3: Black Mastic associated with white 12x12" floor tile and gray 12x12 floor tile, observed in the Original building. Sample numbers 76-B and 78-B.

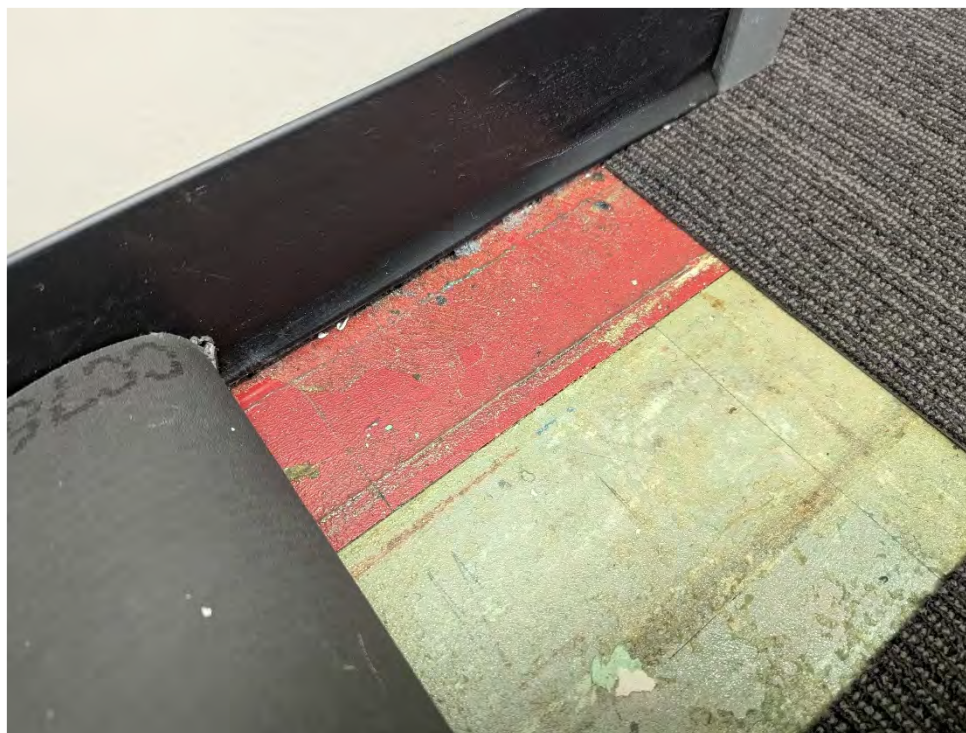
Photograph 4: Red 9x9" floor tile that has black mastic, observed in the Original building. Sample number 174-B.

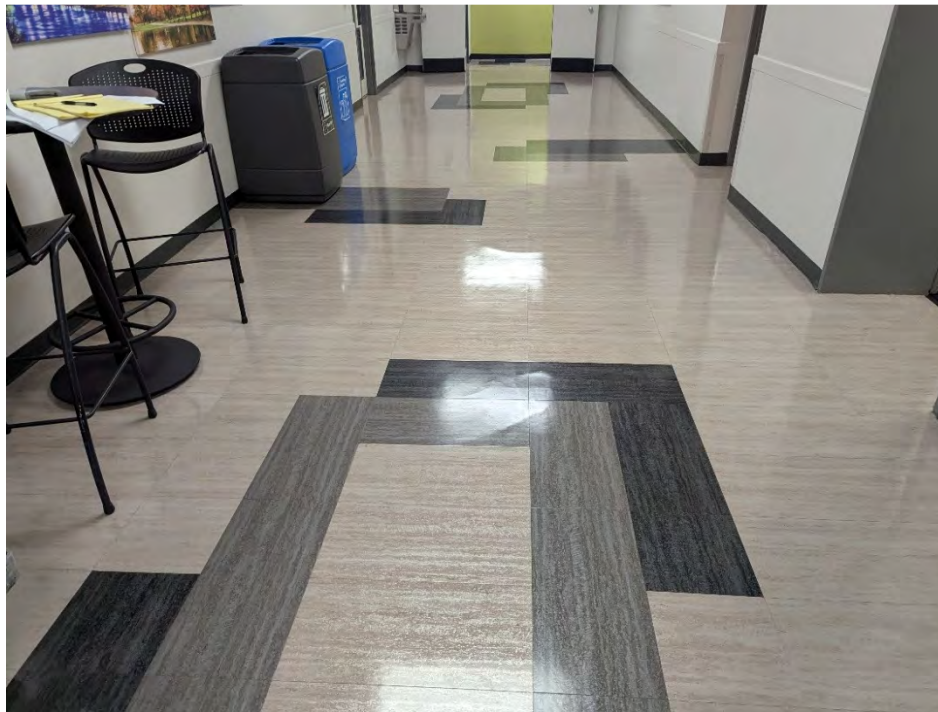
Photograph 5: Black and tan mastic associated with tan with streaks 12x24" floor tile, black with streaks 12x24" floor tile, and gray with streaks 12x24" floor tile, observed in the Addition. Sample numbers 58-B, 60-B, and 62-B.

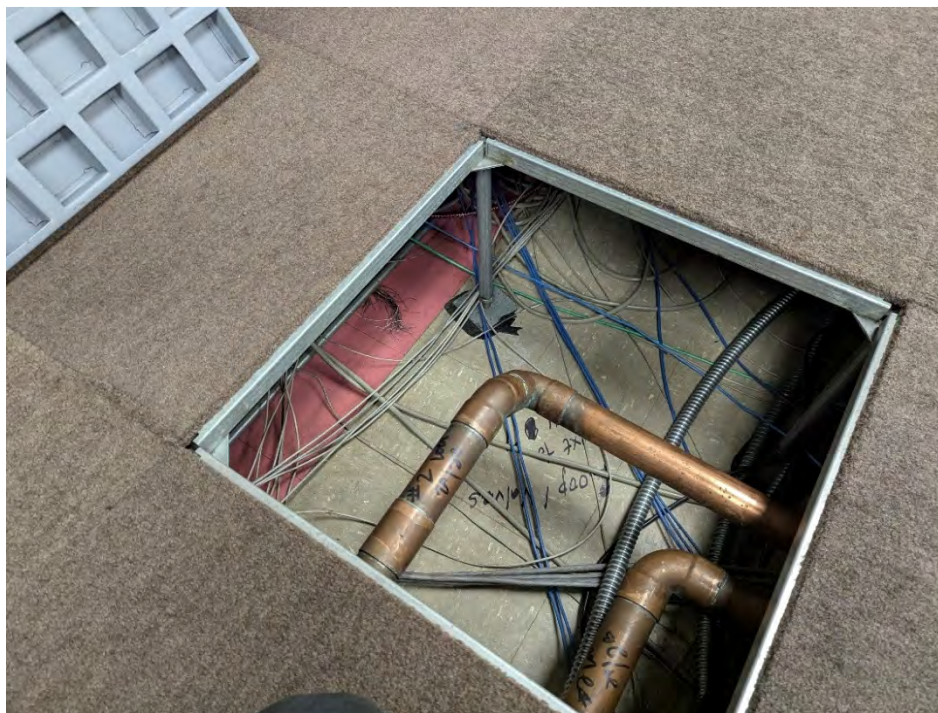
Photograph 6: Black mastic associated with red 12x12" floor tile, observed in the Addition. Sample number 66-B.

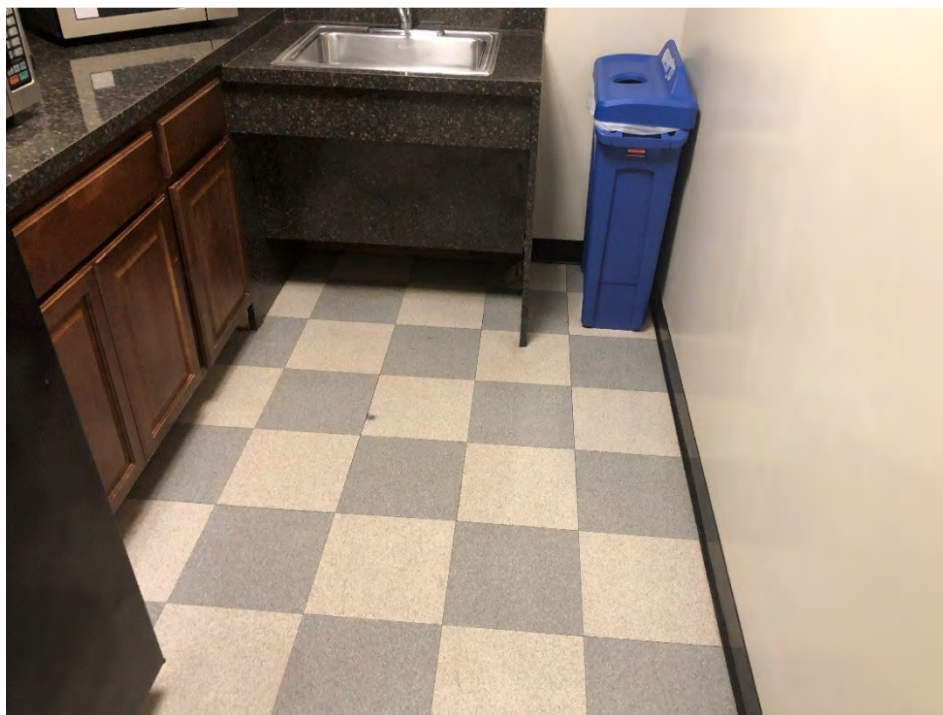
Photograph 7: Brown mastic associated with gray with black and white specs 12x12" floor tile and white with black and grey specs 12x12" floor tile, observed in the Tower. Sample numbers 61-B and 63-B.

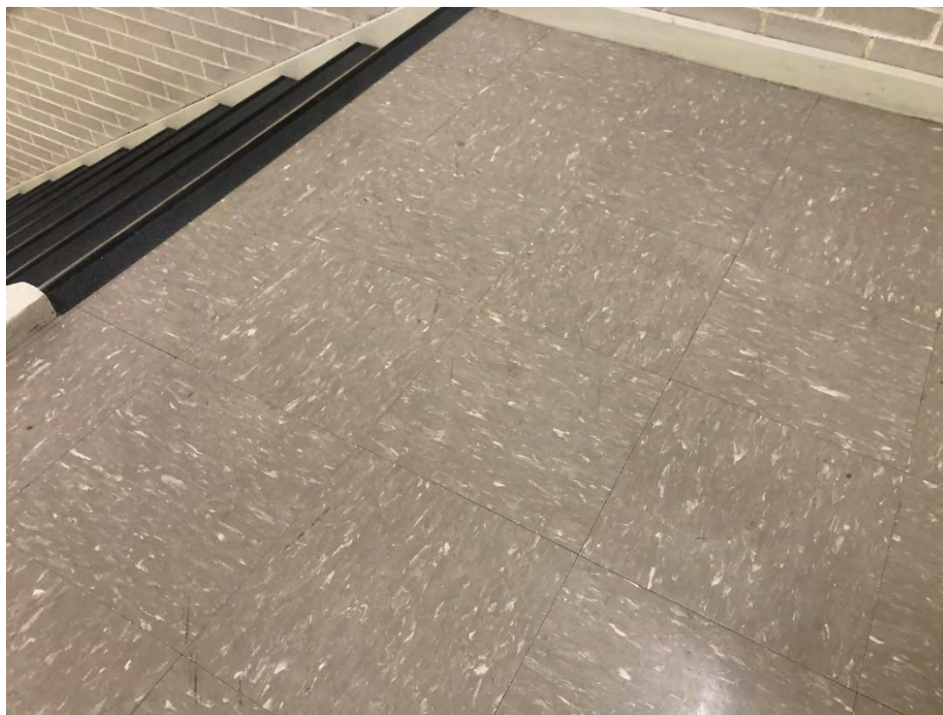
Photograph 8: Gray with white streaks 12x12" floor tile, observed in the Tower. Sample number 69-A

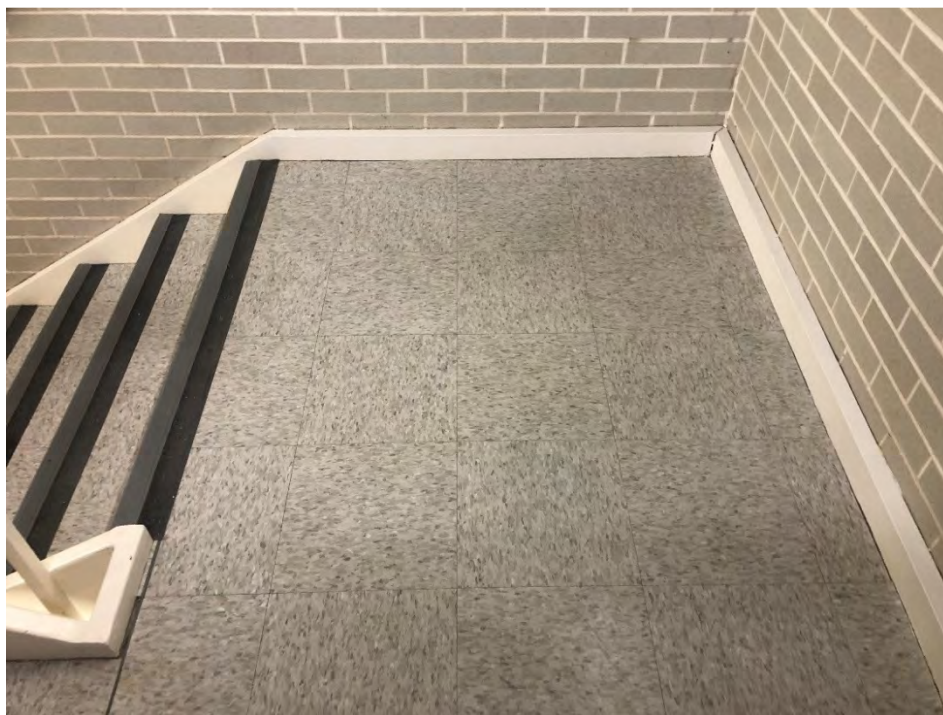
Photograph 9: Black mastic associated with white with gray streaks 12x12" floor tile, observed in the Tower. Sample number 74-B.

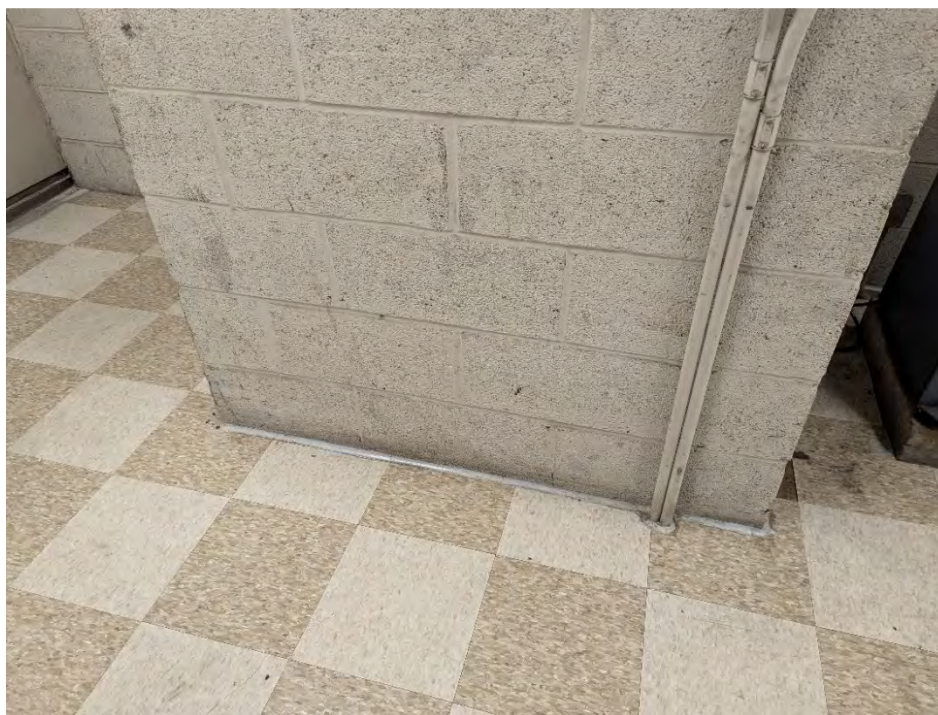
Photograph 10: Mastic associated with white with tan streaks 12x12" floor tile and tan with white streaks 12x12" floor tile, observed in the Tower. Sample numbers 86-B and 88-B.

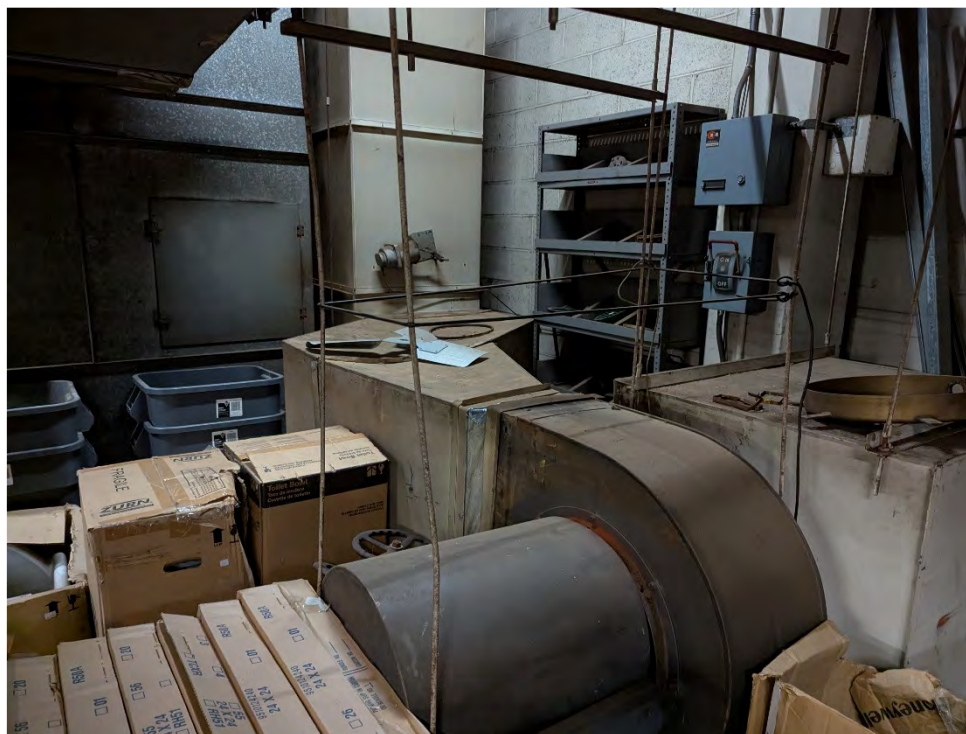
Photograph 11: White duct vibration dampener, observed in the Tower. Sample number 109.

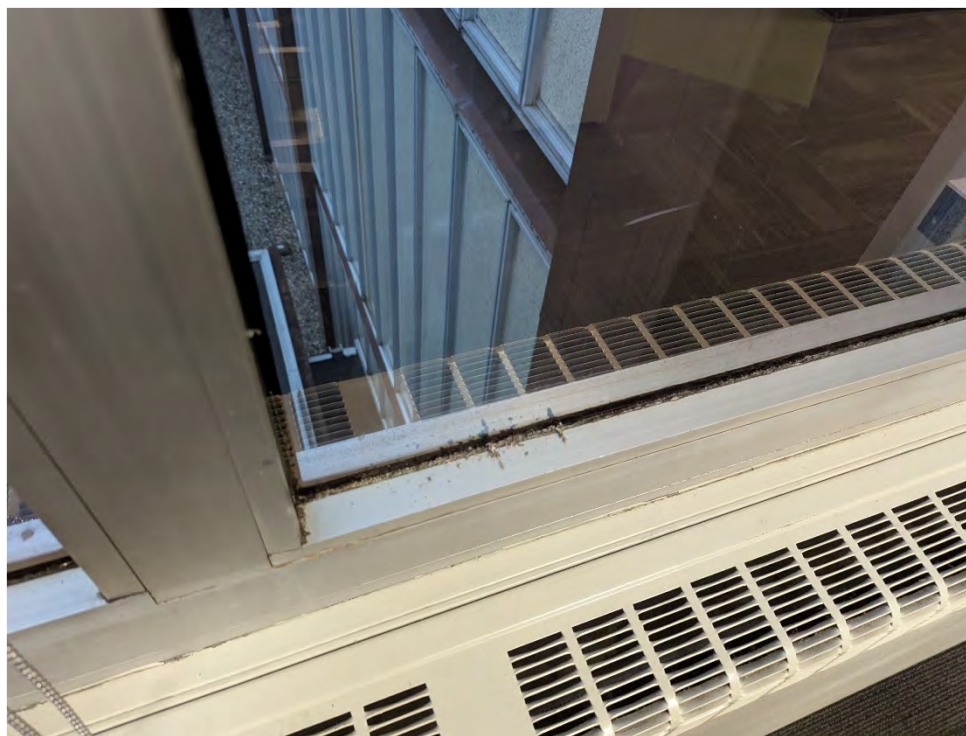
Photograph 12: Black interior window caulk, observed in the Addition. Sample number 26.

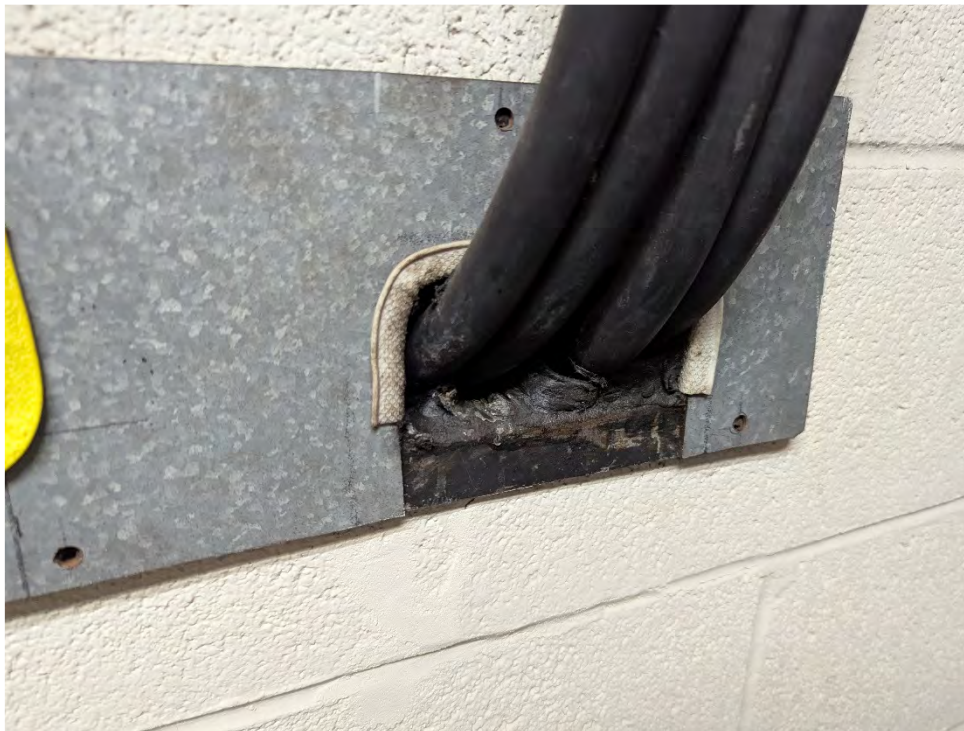
Photograph 13: Black penetration sealant, observed in the Addition. Sample number 79.

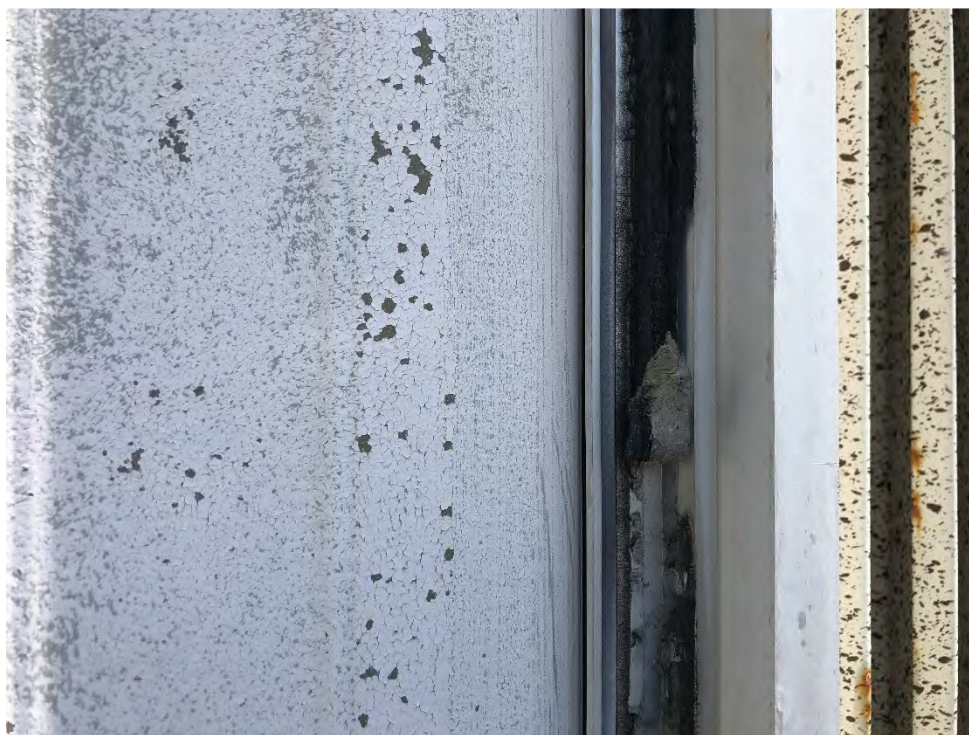
Photograph 14: Silver/gray sealant on exterior panel of mechanical wall, observed on the Addition. Sample number 107.

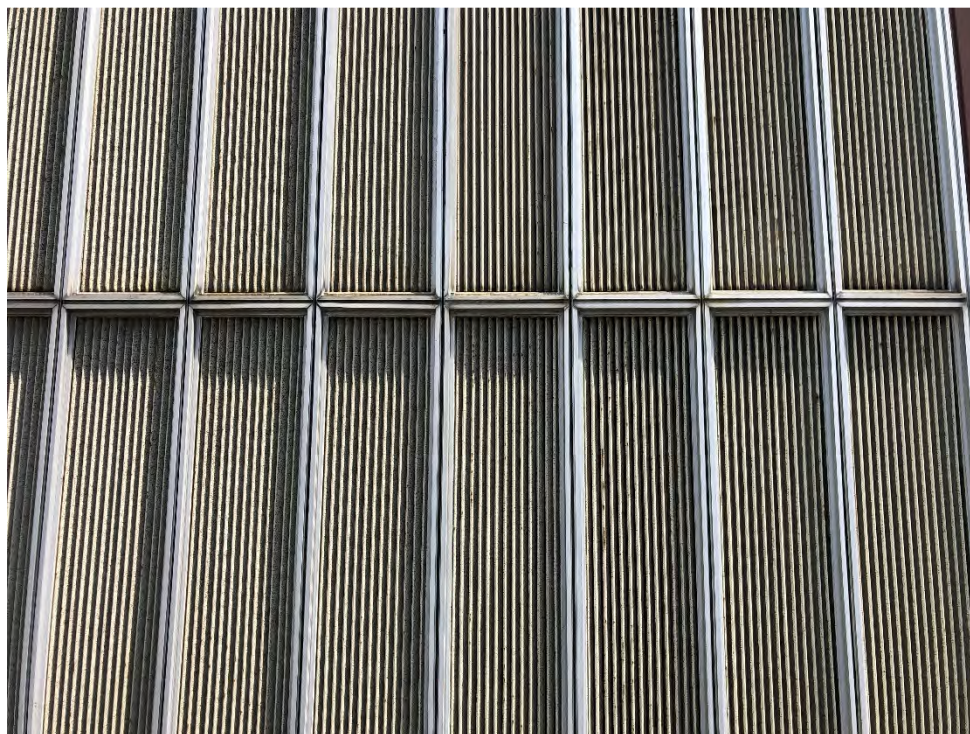
Photograph 15: Silver/gray sealant on exterior panel of mechanical wall, observed on the Addition. Sample number 107.

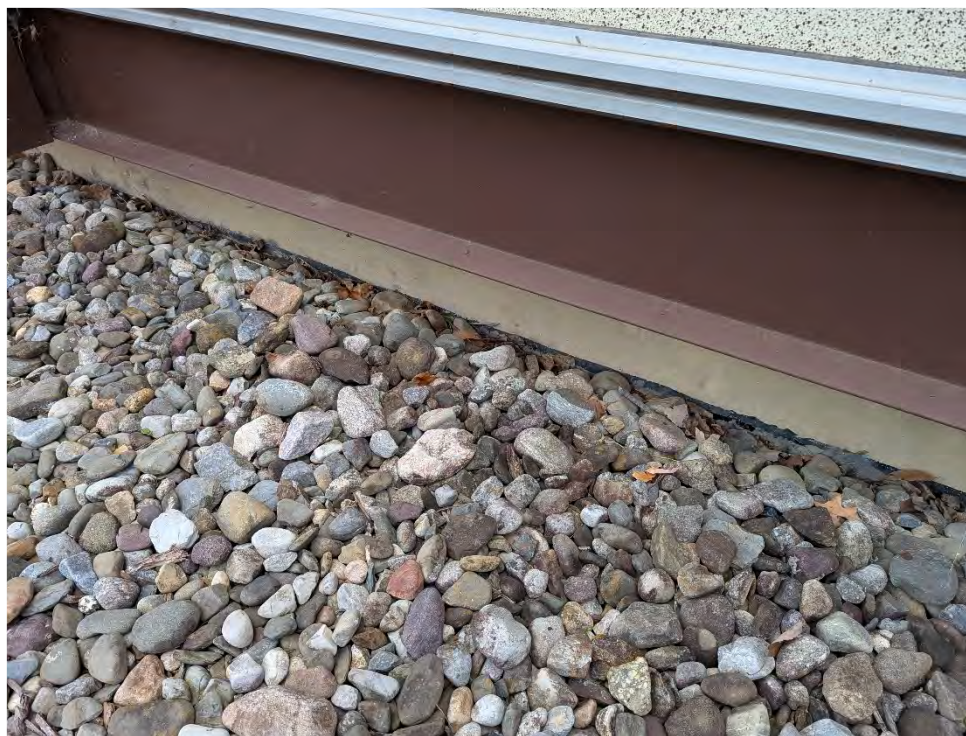
Photograph 16: Concrete waterproof sheeting, observed in the Addition and Tower. Sample numbers 119 and 118, respectively.

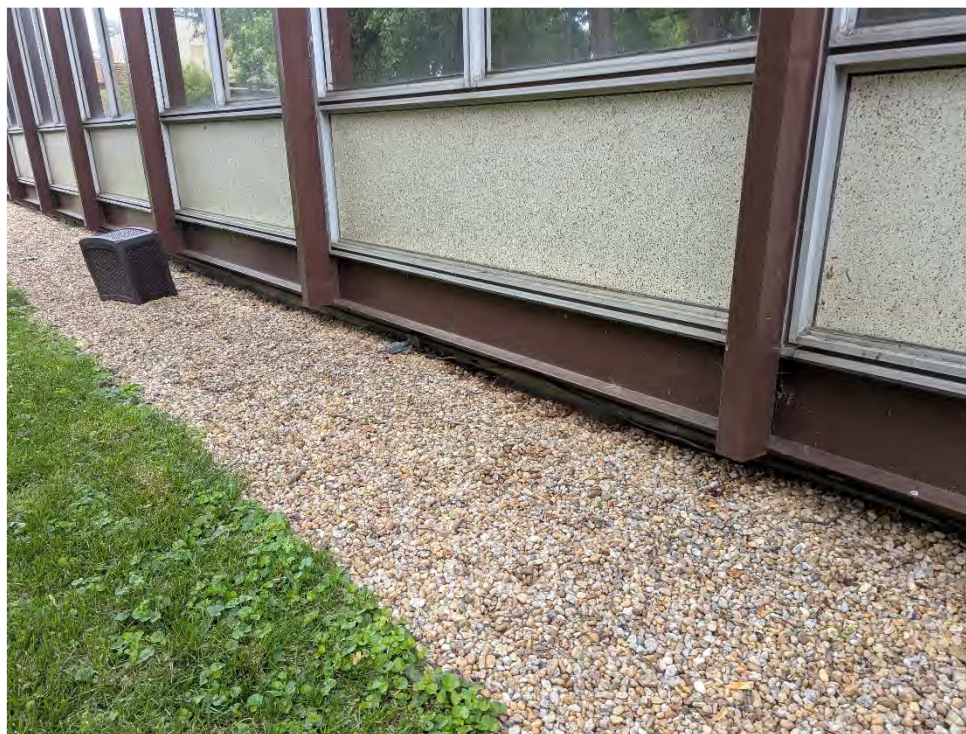
Photograph 17: Concrete waterproof sheeting, observed in the Addition and Tower. Sample numbers 119 and 118, respectively.

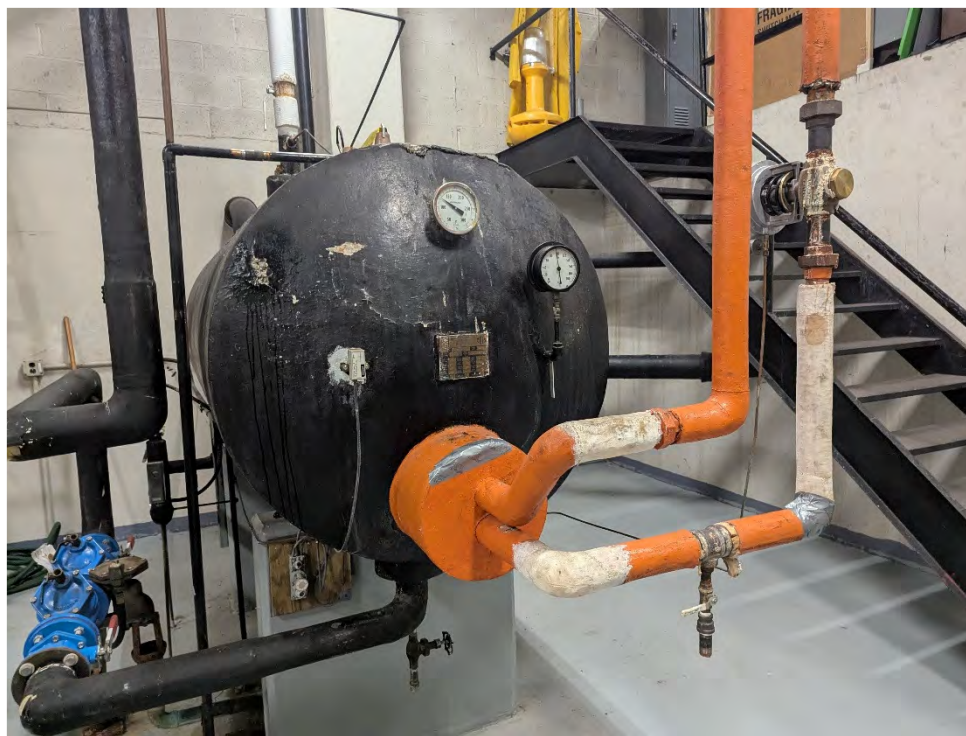
Photograph 18: Insulation and canvas on small black water heater, observed in the Tower. Sample number 8.

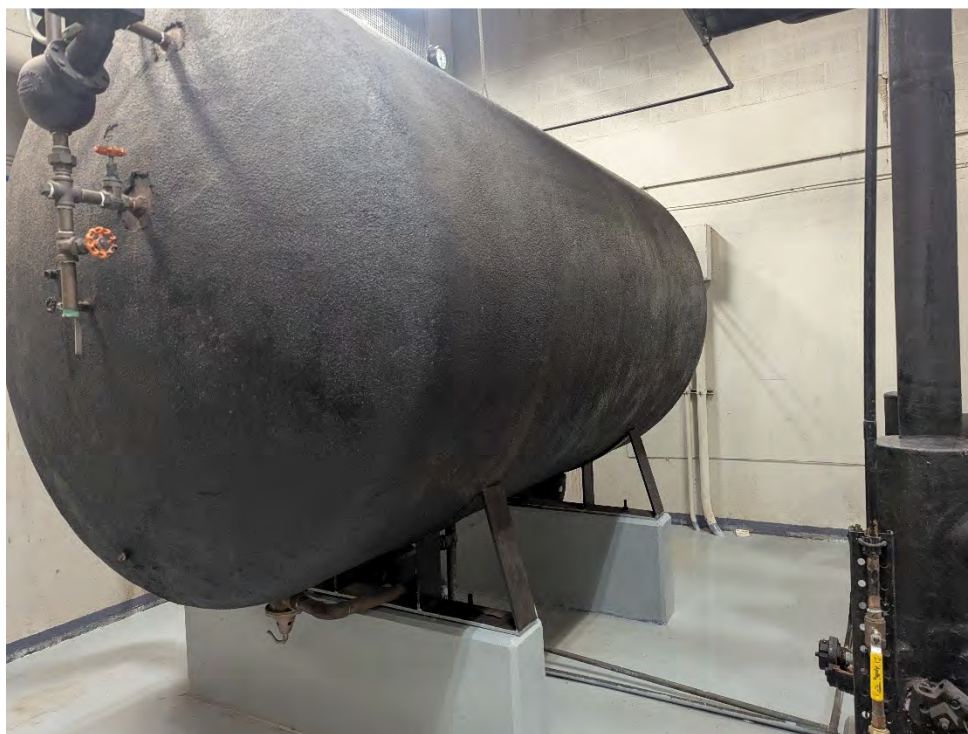
Photograph 19: Tar coating on large black water heater, observed in the Tower. Sample number 11.

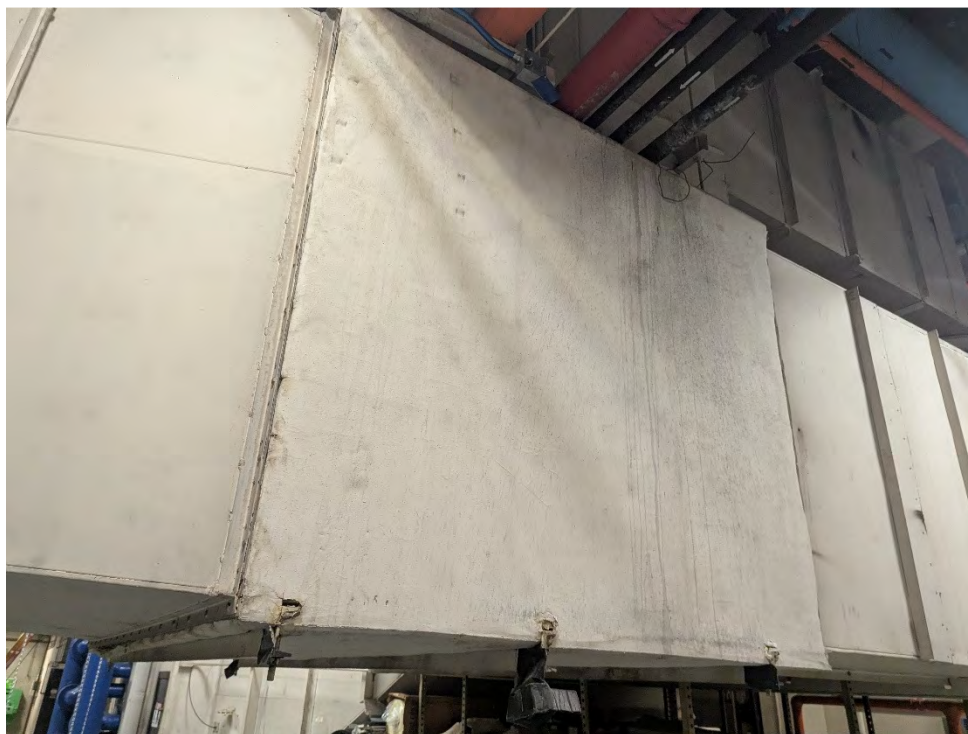
Photograph 20: Canvas on duct, observed in the Tower. Sample number 16.

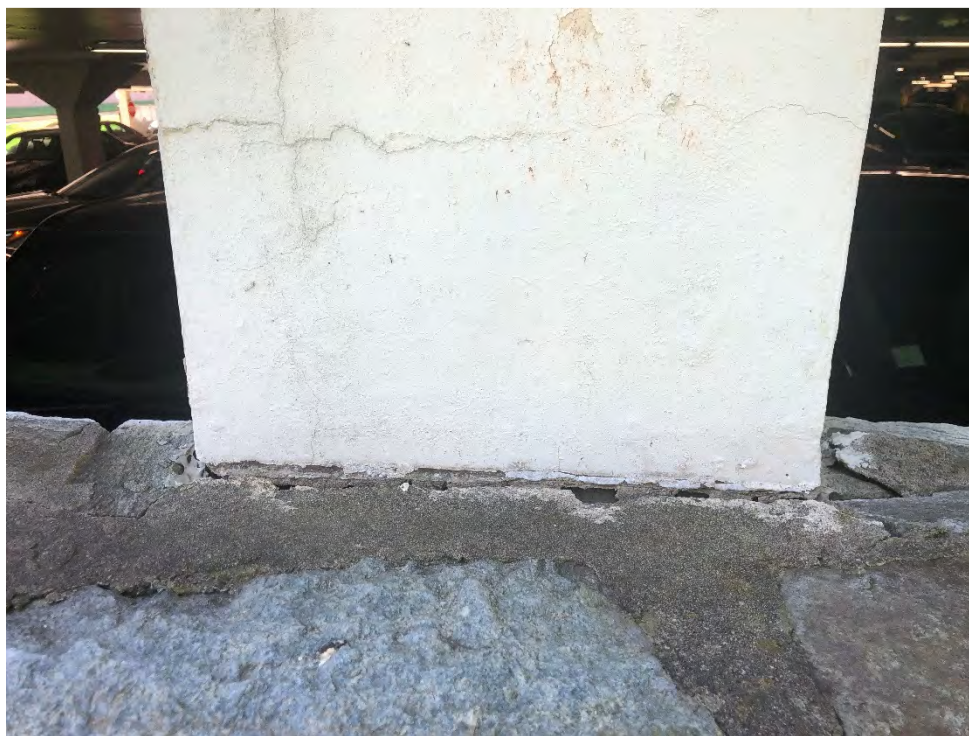
Photograph 22: Sealant between stone and column, observed in the Tower garage. Sample number 110.

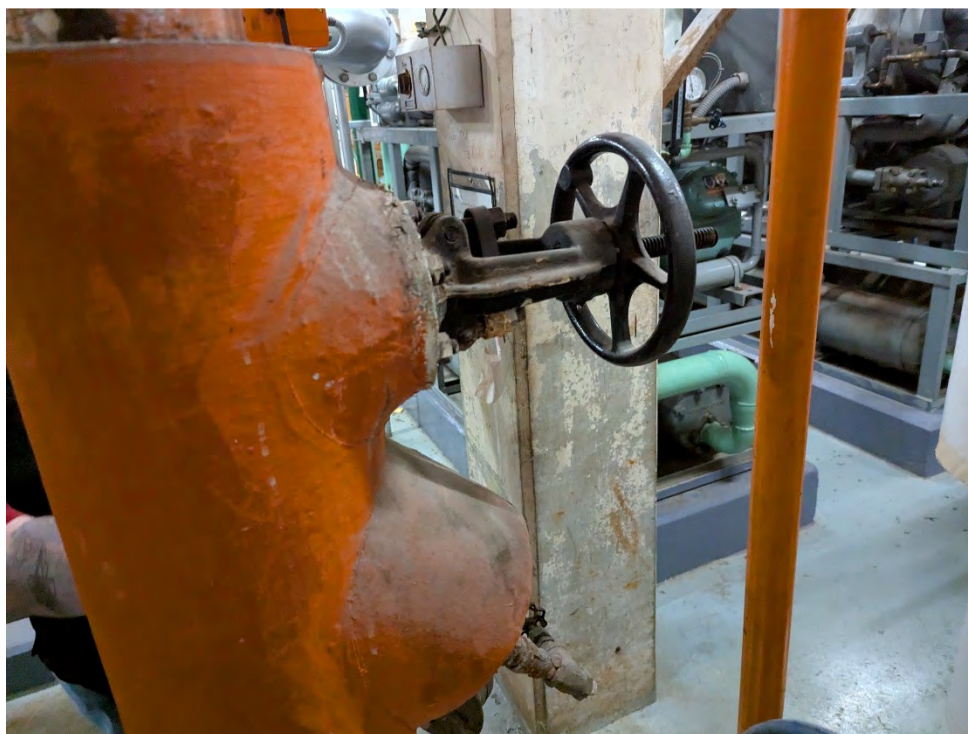
Photograph 23: 12" pipe fitting (orange), observed in the Original building. Sample number 106.

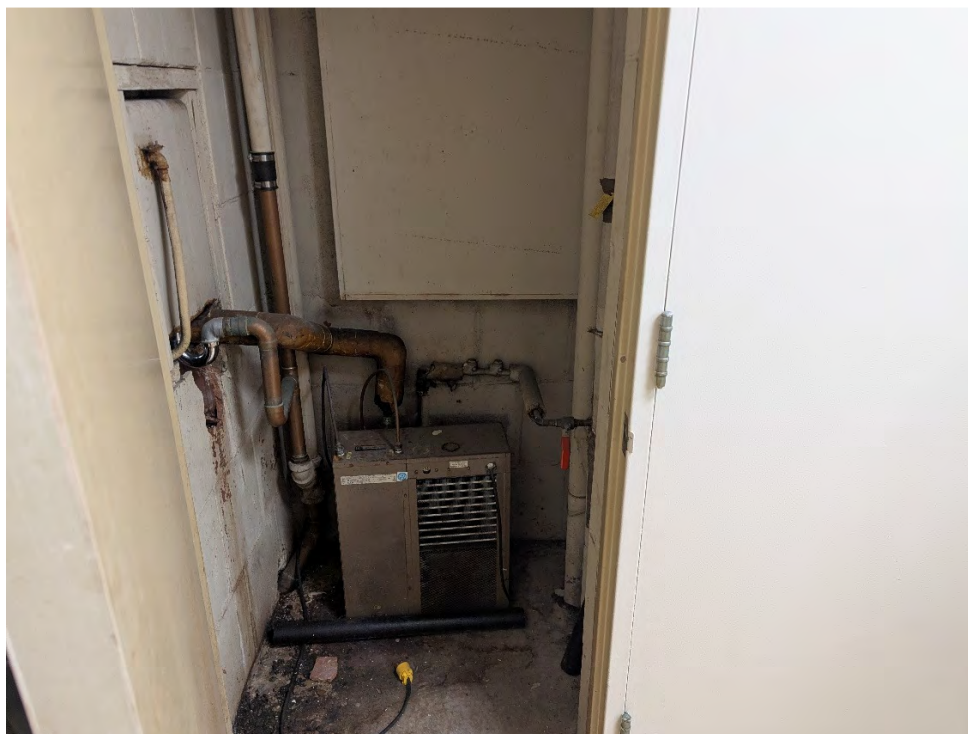
Photograph 24: 1"-3" pipe fitting, observed in the Original building. Sample number 149.

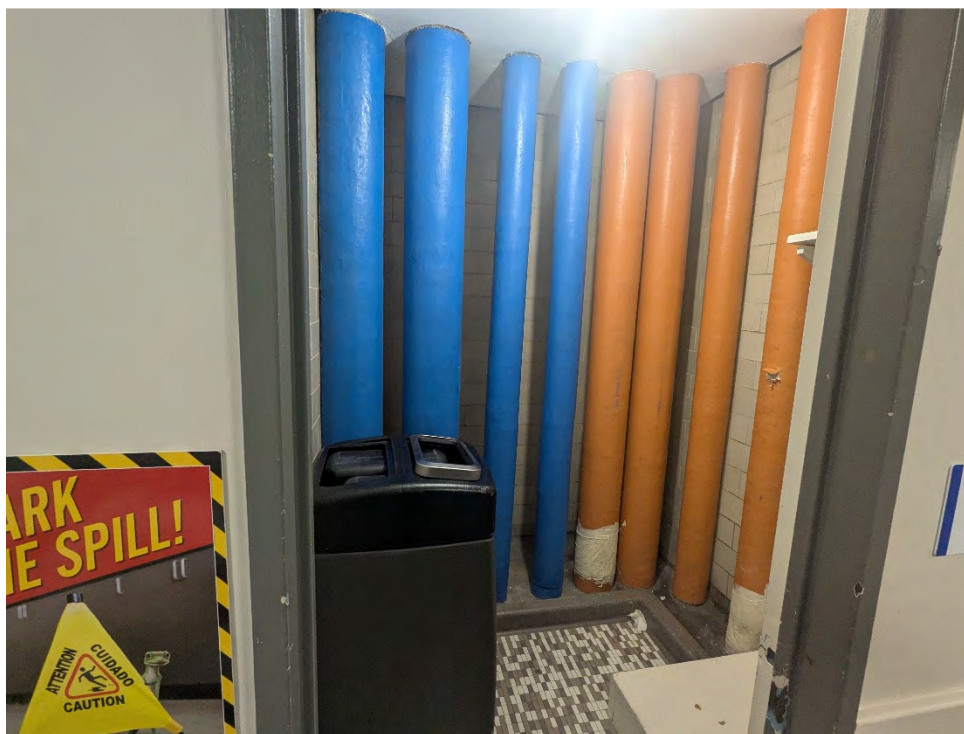
Photograph 25: pipe insulation greater than 6", observed in the Original building. Sample number 159.

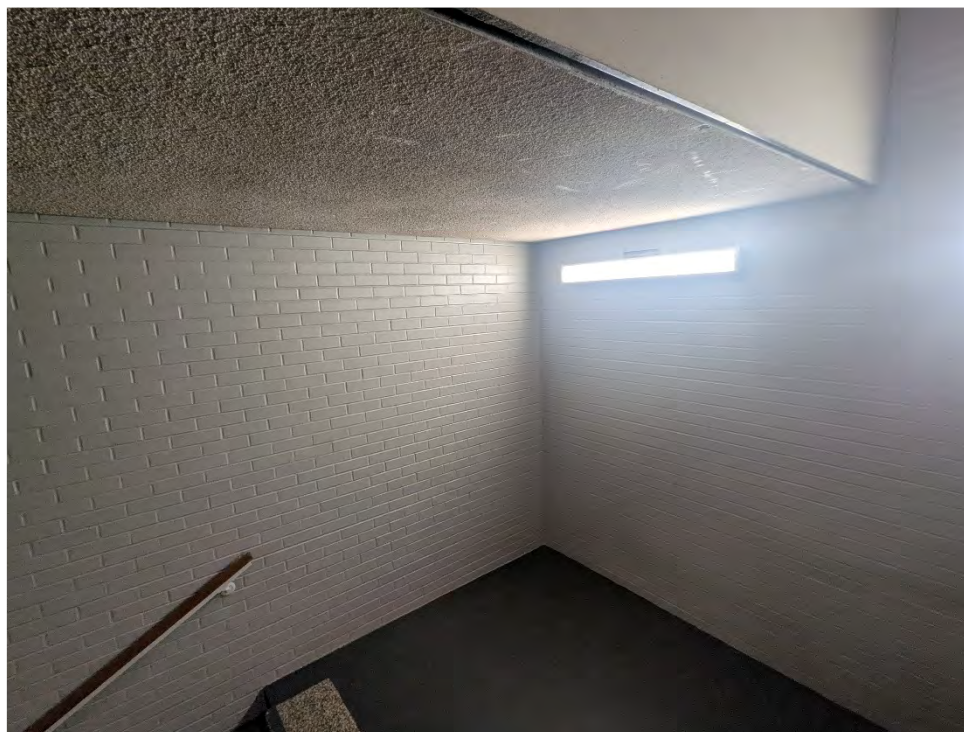
Photograph 26: Textured ceiling, observed in the Addition. Sample numbers 5 and 124

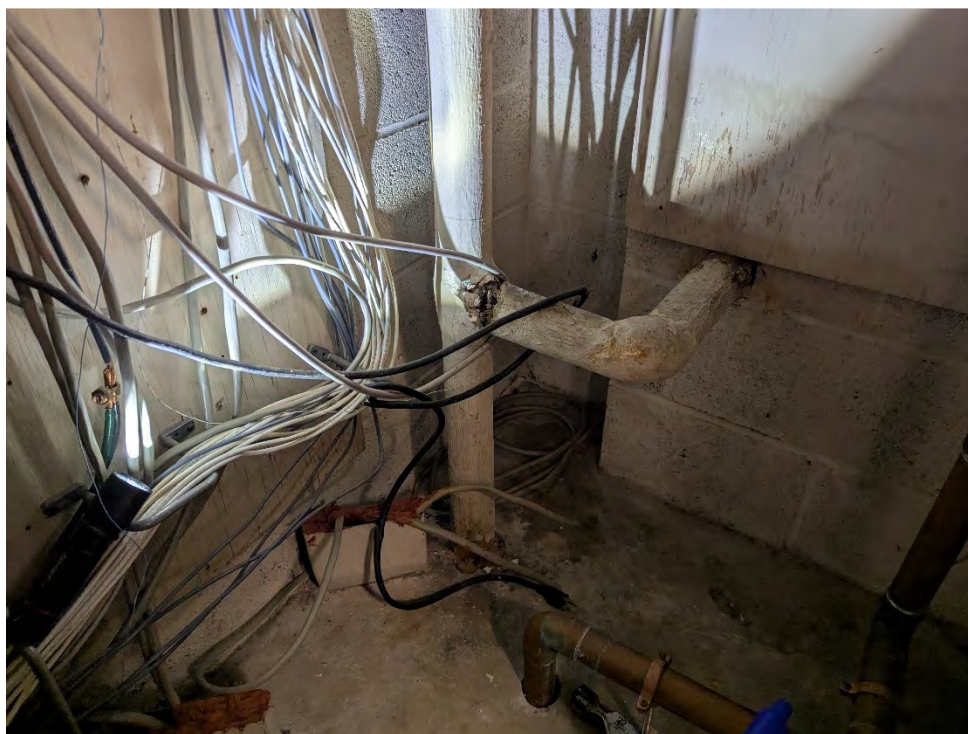
Photograph 27: 1"-3" pipe fitting, observed in the Addition. Sample number 19.
